Monitoring Data Record

| Project Title: R-2635C Western Wake Freeway COE Action ID: 2007-02903-292 |
| Stream Name: <u>UT Reedy Branch – Site 3</u> <u>DWQ Number: 20071470</u> |

Year 2 Winter - January 2012

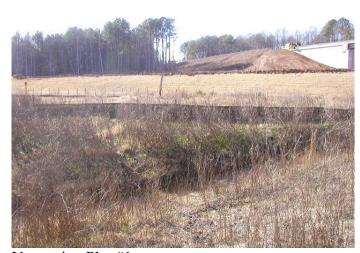
Vegetation Plot #1

It was noted in 2011 that the buffer was not planted at 680 trees per acre but at a lower stem count resulting in the low at planting numbers for vegetation plot #1 (23 trees) and plot #2 (33 trees).

Estimated causes, and proposed/required remedial action: A supplemental planting was completed on January 12, 2012. Bareroot seedlings were added in the buffer and additional live stakes were planted at the previously noted headcuts. This supplemental planting has increased the at planting numbers for vegetation plot # 1 (35 trees) and plot # 2 (39 trees).

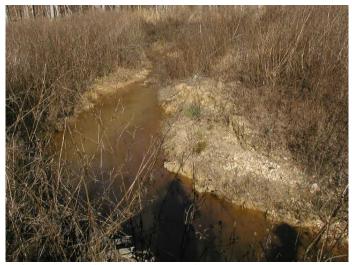
| 1/18/12 | Station | Station | Station | Station | Station |
|---|---|---|---|---|---|
| Bank or | Bank scouring | | | | |
| scour erosion | along left bank | | | | |
| present? | upstream of | | | | |
| • | PP#2 | | | | |

Left Bank Scouring @ STA. 321+50-L-

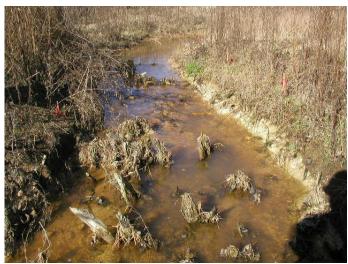
| 1/18/12 | Station | Station | Station | Station | Station |
|---|---|---|---|---|---|
| Head cut or | | Slight Headcut | Headcut has | | |
| down cut | | has formed | formed | | |
| present? | | upstream of | downstream of | | |
| | | PP#4 | PP#4 | | |

Slight Heacut @ STA. 318+90-L-

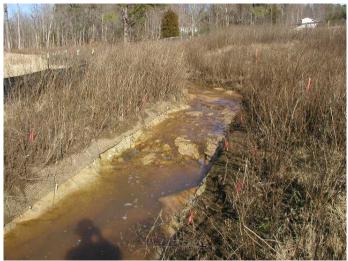
Headcut @ STA. 317+70-L-
